Emergency Compressor Repair Restores Paper Mill Production in Record Time

Paper and packaging manufacturing plant, Savannah, Georgia

Three-stage, high-vacuum blower

Minimize downtime caused by a damaged rotor in a critical high-vacuum blower

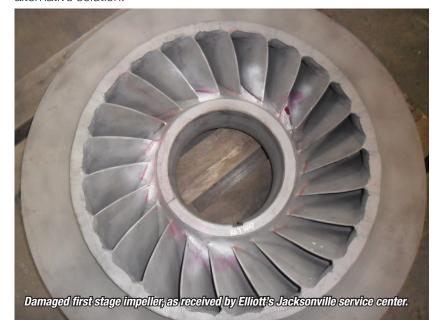
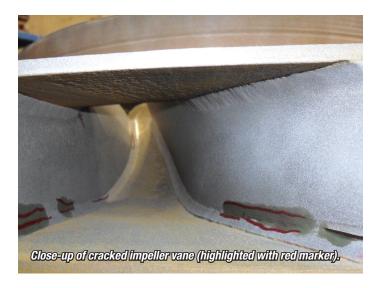
During a routine maintenance inspection in February 2013, the OEM discovered several cracks in the first-stage impeller vanes and determined that the rotor could not be repaired. The OEM proposed a new impeller, which would require 10 weeks to manufacture. With the hope of curtailing this outage and minimizing the significant financial impact on the company, the customer contacted Elliott in search of an alternative solution.

Elliott evaluated the damaged rotor and committed to making emergency repairs to the rotor assembly at Elliott's Jacksonville service center. The scope of the repairs included:

- Excavation of cracks
- Weld repair
- Pre- and post-weld heat treatments
- Impeller balancing
- Shaft machining
- Overspeed spin test
- Dynamic rotor balancing
