Restoration of Two Spare Rotors Gives New Life to Steam Turbine Generator Train

High Pressure/Intermediate Pressure (HP/IP) steam turbine and Low Pressure (LP) steam turbine

Qualify and repair two non-Elliott steam turbine rotors for use as spares for a different steam turbine generator train.

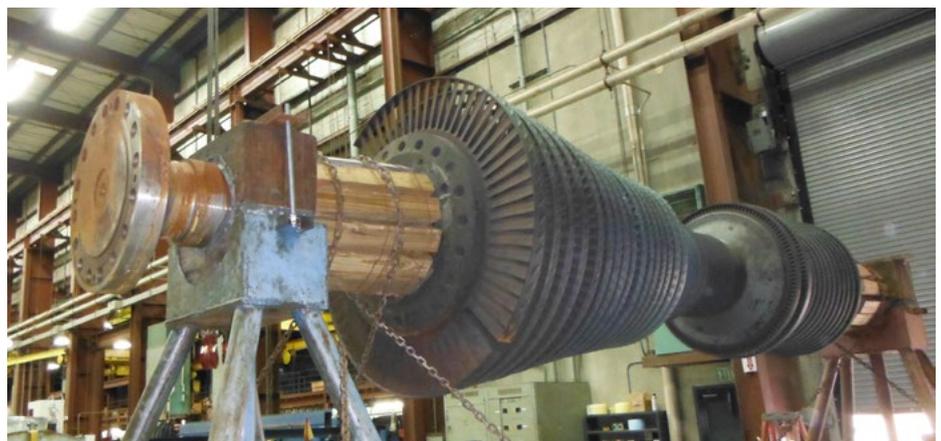
The spare rotors had been in operation since 1958. With a nearly 60-year running time frame, including numerous starts and stops, it was important to perform a remaining useful life assessment on both rotors to verify that the rotor forgings still had life left. After conducting the assessment at the Jacksonville Service Center, Elliott determined that both rotors had useful life remaining, and therefore, it was worthwhile to proceed with the necessary repairs.

HP/IP rotor prior to inspection and repair at the Jacksonville Service Center.

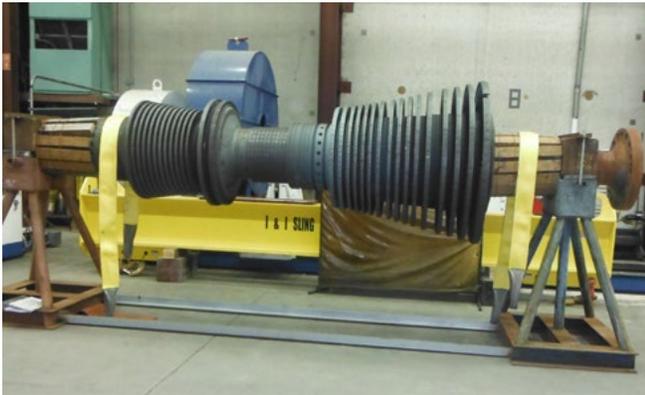
Elliott was aware that this particular HP/IP rotor had a history of disk cracking, so the service center took extra precaution during the NDT and removed rows of blades, one by one, to inspect for cracks. NDT revealed cracks in the first seven stages of the IP section of the rotor. Elliott determined the best plan of action and most cost-effective solution was a rotor weld restoration.

HP/IP rotor before inspection and repair.

To repair the HP/IP rotor, Elliott machined down the rotor body blade slots, weld restored the rotor body, re-machined the blade slots, installed new blades, and balanced the rotor.

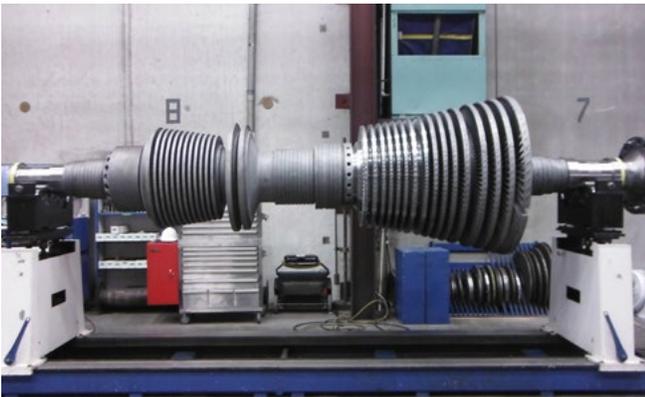
HP/IP rotor after inspection and repair.

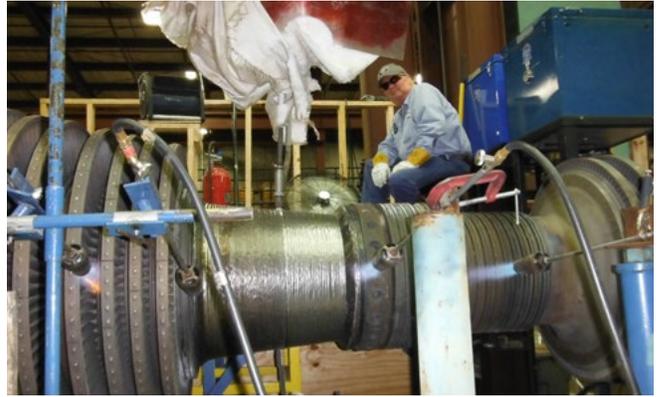
Sub arc welding process.

Rotor weld restoration requires specialized training, advanced techniques, and special procedures to re-establish rotor integrity. The Jacksonville Service Center performed automated submerged arc welding (SAW) of high-chrome alloy metal which requires very high interpass temperatures. The welding process was performed around the clock, non-stop, for 12 days (24 shifts).

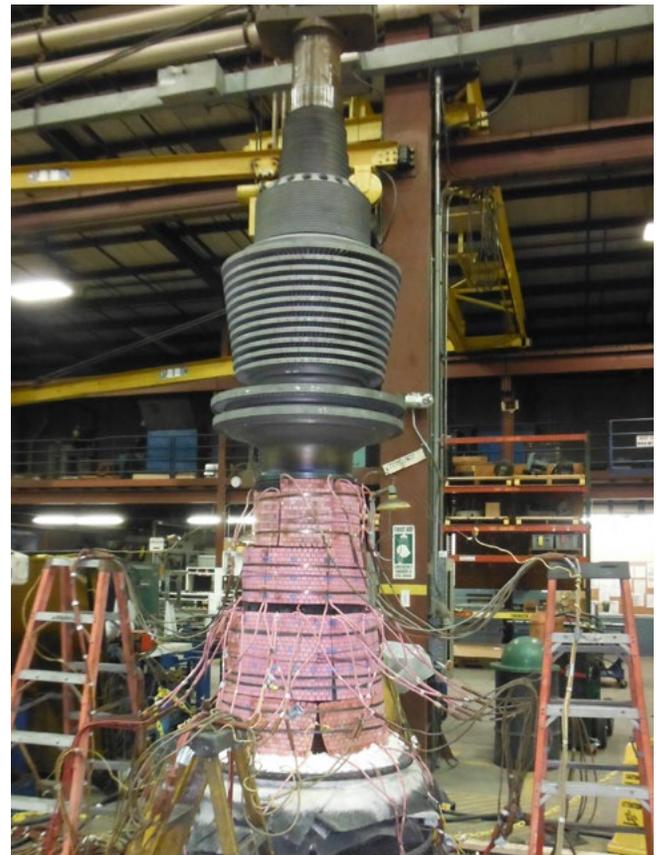
Vertically hung stress relief process.

Once the welding process was complete, the rotor required vertically hung stress relief.

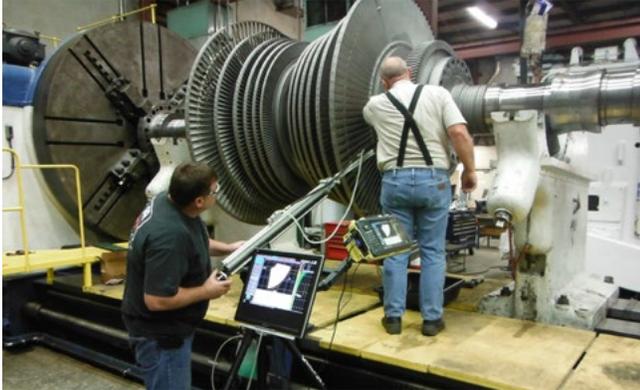
The inspection of the double flow LP rotor revealed foreign object damage to the inlet stages and excessive erosion damage to multiple stages on both ends of the rotor. This repair required re-blading of six stages – three on the turbine end, and three on the generator end.

Technicians performing Phased Array Ultrasonic Testing (PAUT) to the shrunk on L-0 disks.

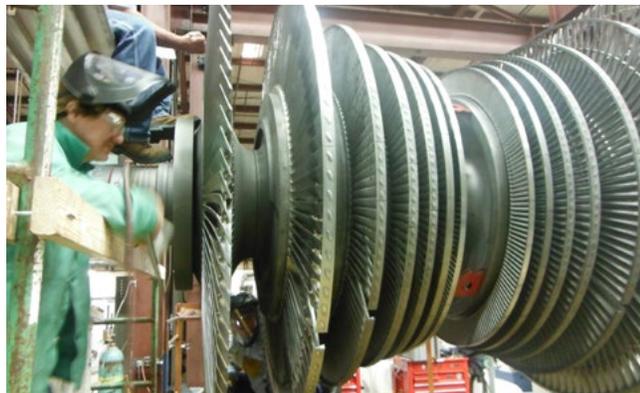
Three Elliott technicians welding and back grinding blade lashing lugs.

Re-blading a rotor is a complex process that requires precision, accuracy, and teamwork. The last stage of this double flow LP rotor, for instance, was a double lashing lug design that required multiple technicians working at the same time. One technician was welding, one was grinding, and one was dye penetrant testing.

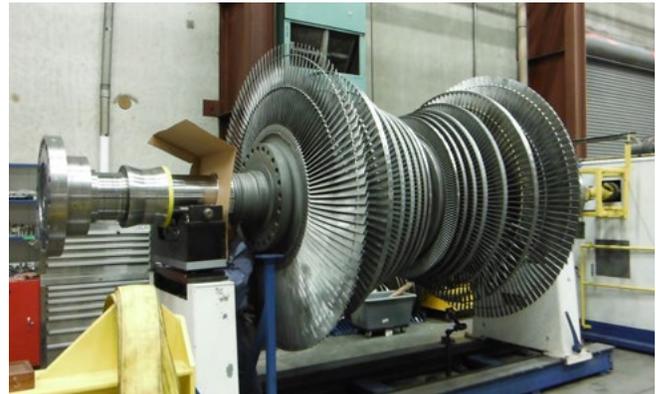
Final balance of the LP rotor.

Once the HP/IP rotor and the double flow LP rotor were repaired, both were high speed balanced to ensure reliable operation.

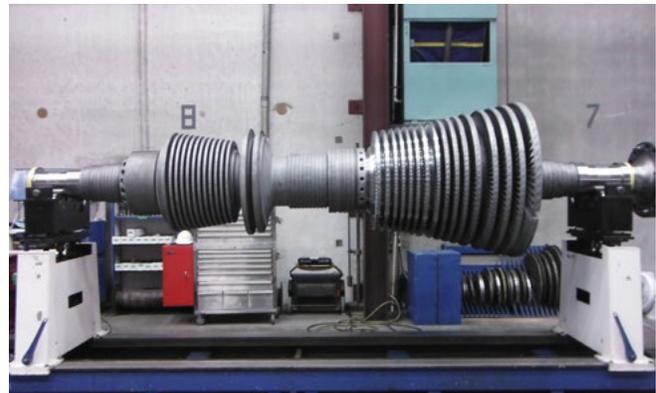
Final balance of the HP/IP rotor.
