Hitting a moving target

Scot J. Laney, Elliott Group, USA, presents a targeted approach to anti-fouling coatings.

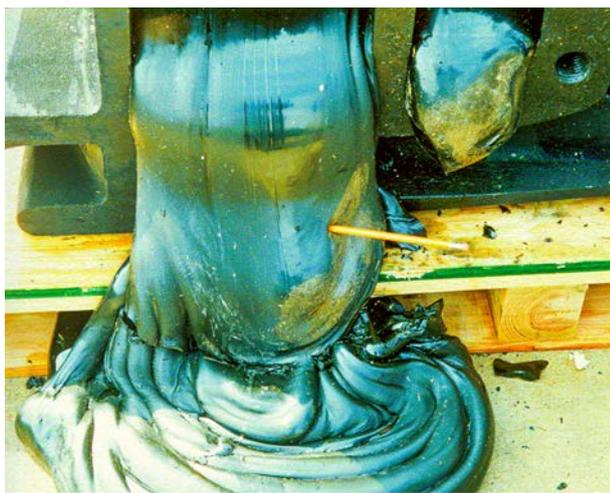
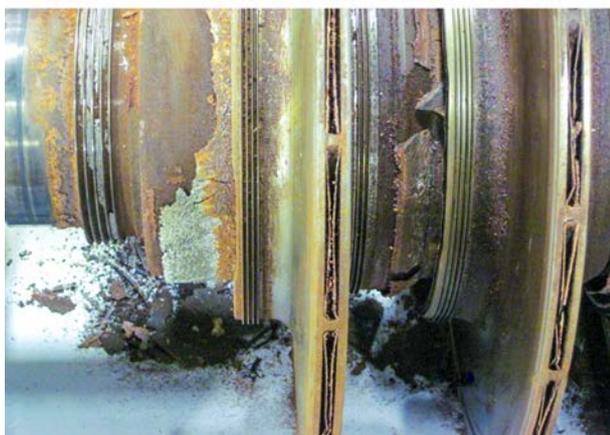
Figure 1. Examples of fouling caused by internal polymerisation (top) and salt carryover (bottom).

These industry standard coatings are applied to compressors in all services that cause fouling, yet the data sheets, and virtually all of the (albeit limited) published testing data on their fouling resistance, relates to hydrocarbon fouling. This type of internally generated fouling occurs when the process gas polymerises inside the compressor and condenses polymeric materials on the flow surfaces. Hydrocarbon fouling is extremely problematic, and in some cases can be spectacular, as evidenced in Figure 1 (top), where foulant with a tar-like consistency oozes from the compressor.

Unfortunately, these same coatings are also used, with little to no validation, in other services or conditions where the foulant originates as carryover from upstream processes. This type of foulant can be very different relative to internally generated foulant. Figure 1 (bottom) shows the build-up of chloride salts carried into a hydrogen recycle compressor. Not only do these salts restrict flow passages, they can also cause severe under deposit corrosion even in stainless steel and nickel based alloys.

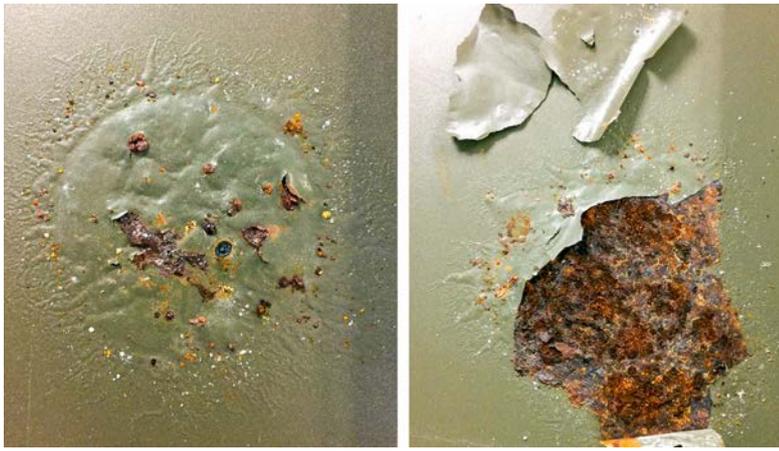
Figure 5. Exposed area of a permeated coating immediately after test (left) and after peeling back the coating to reveal the substrate (right).

the other coatings that were rapidly permeated was that the aluminium in the base coating was aggressively attacked by the electrolyte. Figure 4 (right) shows the EIS results from a coating that behaved this way, and Figure 5 shows the exposed area after the test was completed. This indicates that the use of the aluminium filled cermet base coating is probably not a good idea in a hydrogen recycle application.
