IMPROVING

RELIABILITY

Mike Minnerly and Taylor Birckbichler, Elliott Group, USA, discuss how a rerate of a refiner's poorly performing hot gas expander resolved its reliability issues.

Expander rerate case study

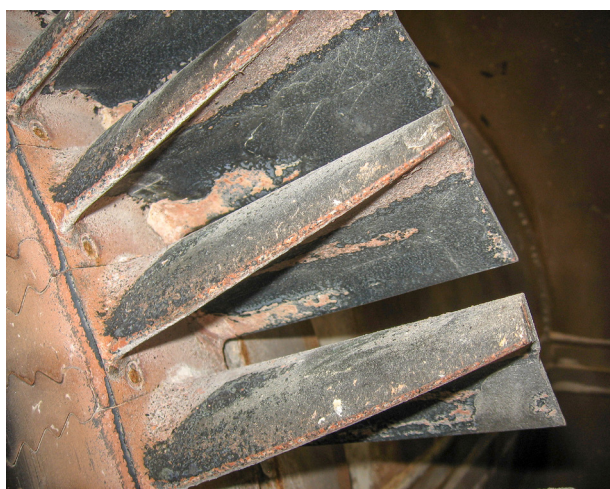
Figure 3. TH-100 rotor blades as received after the first five year run.

Similarly, the spare rotor and bearing pedestal were used as part of the build. The rotor blades, which had previously seen severe primary and secondary erosion, survived the operating campaign with only some tip wear that has been attributed to catalyst buildup on the rotor shroud ring. This type of wear is repairable and the blades are expected to be returned to service.

Elliott's rotor assembly has blades and disks that can be manufactured from high-performance superalloys such as Waspaloy or the RK1000 superalloy, which has excellent corrosion resistance and is particularly effective against sulfide penetration that promotes hot corrosion. For the rerate application, Waspaloy blades and disks were used (Figure 3). A sacrificial chrome carbide coating was applied to the airfoils to aid in preventing erosion of the base material.

The TH expander rotor design incorporates an axial spline to attach the rotor disk to the shaft rather than the radial pins and rabbet fits typical of other designs. The spline design contributes to rotor reliability by maintaining concentricity and avoiding the stresses incurred by rabbet shrink fitting. The TH design also features a reliable blade root. The enhanced fir tree design features four lands instead of three, reducing stress at the blade root and extending blade life. A no-stress locking rivet removes the need topeen the blade root in position, and thus eliminates the stress on the metal that peening can cause.

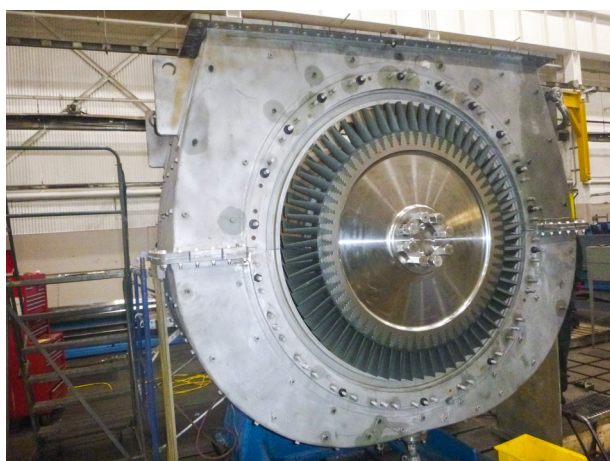
Figure 5. Cleaned and partially reassembled TH-100 expander.

The stator assembly was replaced with the customer-supplied spare part to minimise the

overhaul schedule. A visual inspection of the spent stator assembly, however, revealed no signs of cracking or erosion.
