Laser welding for Turbomachinery rotor restoration

By Michael W. Kuper,

Michael J. Metzmaier,

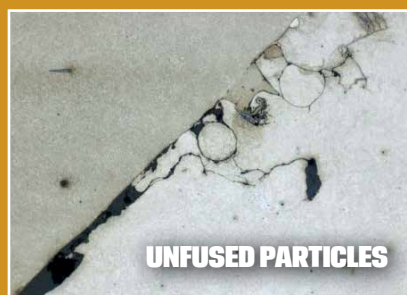
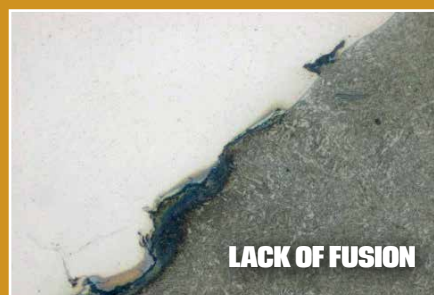
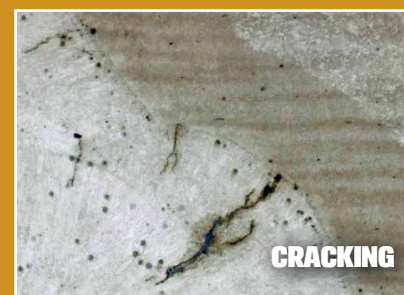
UNFUSED PARTICLES

LACK OF FUSION

CRACKING

FIGURE 3 Typical defects that occur in laser welding. These defects were found in a weld made using powder based filler metal delivery. Porosity can be seen speckling each image.

From an applications standpoint, one major difference between powder-based and wire-based laser welding is the type of defects and the likelihood of forming defects during welding. LBW-W is capable of producing fully dense, defect-free welds, while LBW-P usually has a small amount of porosity at a minimum. Regardless, suboptimal welding parameters, joint geometry, or conditions can generate defects for either process. Typical defects that occur in laser welding include the following, with examples shown in Figure 3, which shows defects in an LBW-P overlay.

Porosity is characterized by voids that occur within the weld deposit, created by escaping gases that become trapped during solidification. For LBW, there are several methods by which gasses can be introduced into the weld pool, but the main theories include trapping shielding gas or metal vapors, cavitation caused by unstable keyhole welding, and gasses that were entrapped in the powder particles during the atomization process and released during

Lack of fusion is characterized by locations where the filler metal did not fuse with the base metal. This occurs when the heat source generates insufficient heat to coalesce the filler and base metals. The typical causes for this include poor welding angle, excessive filler material feed rate, and/or inadequate laser power. Similar to lack of fusion, unfused particles are characterized by remnants of unmelted powder being present in the weld. This type of defect is exclusive to LBW-P because it involves powder while LBW-W does not. The cause of unfused particles is similar to lack of fusion, where there is insufficient heat to fully melt and fuse the filler material with the base material. This generally occurs because the laser did not have the time, power, and/or correct positioning to melt all of the filler metal in the weld area.

Cracking is characterized by weld metal fracture because of stress. Cracking can be caused by a multitude of factors, though common examples include highly restrained joint design, rapid cooling rates, filler metal susceptibility, contamination, weld bead profile, and/or incorrect welding parameters.

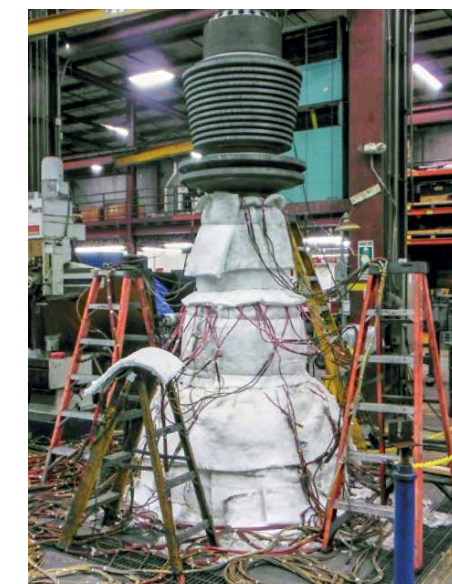
FIGURE 4 Post weld heat treatment setup.

shows the setup for a PWHT applied to a rotor. For this process, the shaft must be suspended vertically to minimize distortion. In other words, if the rotor were heat treated horizontally, the rotor would bow and sag between supports that would become permanent after the heat treatment. After suspending the shaft vertically, heating blankets and thermocouples are added which must provide intense, yet precise heat (generally over 1000 °F), and this heat must be evenly distributed. If heat is added non-uniformly, then stress will be relieved non-uniformly, which could result in detrimental distortion. Heating/cooling rates and hold times must be controlled and monitored carefully. Overall, the process is relatively complex, time-consuming, and costly.

Post weld heat treatment is also a costly and time-consuming operation. Figure 4

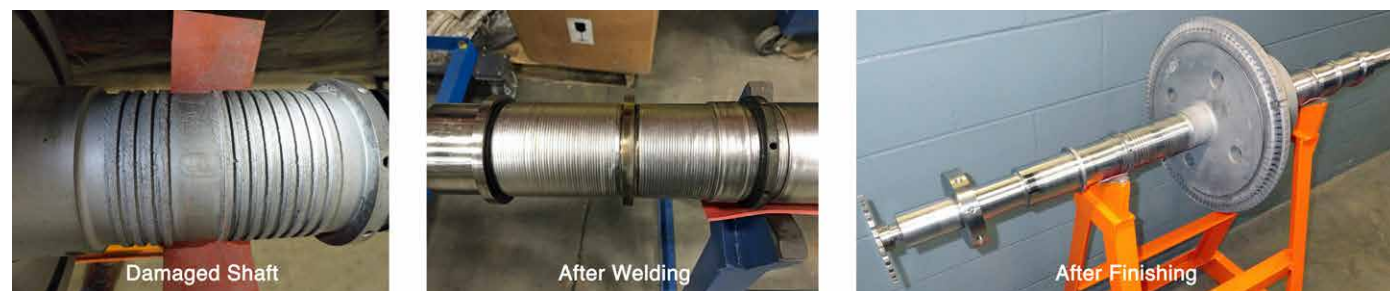
In addition to the mechanical testing performed for the procedure qualification, repair welds were performed on two damaged shafts. The first shaft was damaged by extensive pitting corrosion in the seal, probe, and journal areas, shown in Figure 6. The figure also shows the repaired shaft after welding and after

FIGURE 6 Shaft Damaged by Extensive Pitting

The turbine rotor shown in Figure 6 sustained extensive pitting corrosion damage in the seal and journal locations. Conventional arc weld overlay of those areas would have required a multi-step process to repair. First, all damage and protruding features (i.e., packing teeth, balance rings, thrust disk, etc.) would be machined off of the shaft with an additional undercut of 0.125" radial stock. The shaft would then be welded, building up material as required to restore the geometry of all features, and to account for distortion from the welding process. The weld repair would then require a stress relief heat treatment to remove residual stress. This is necessary because the residual stress would tend to move the shaft during machining, which would result in a high probability of failing to meet the required geometric tolerances. In the case of turbine shafts, removal of residual stress is critical to passing the heat stability check.

By using laser welding, the repair process would require fewer steps. First, the damaged areas would be undercut, though undamaged areas, including protruding features, may be left on the shaft. Second, the LBW overlay would be performed to restore shaft dimensions with an additional 0.020" machining stock. Third, the repair would be machined to meet the drawing dimensions, and lastly, the prescribed non-destructive testing would be performed to check for defects. Overall, this process requires significantly less machining before and after the weld repair, and it eliminates the PWHT. Also, in the case that the rotor is being clad with a corrosion resistant material such as nickel based alloys, LBW deposits less material, which may offer costs savings. It should be noted that the time to overlay weld a shaft may be longer for LBW than a conventional arc welding processes, like submerged arc welding, but the faster machining times and elimination of the PWHT when using LBW generally make up for any time lost during welding by a considerable margin. Of course, this depends on a variety of factors including the size of the rotor, the extent of repairs, the complexity of features, etc., so the best weld repair process for a given application can vary and should be selected on a case-by-case basis. Nonetheless, LBW offers clear advantages in many cases for repair of superficial damage, which occurs commonly over time and exposure to service conditions.

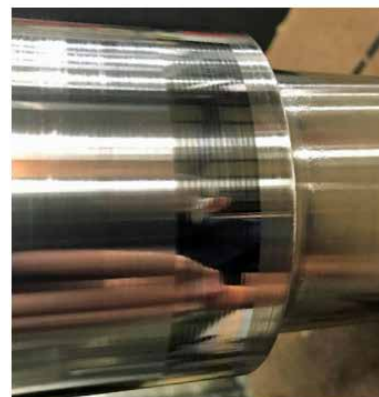
final machining. The probe area was also ground and burnished, which can be seen in Figure 7 along with the electrical runout measurements. The difference in color

between the repaired area and the rest of the shaft resulted from the difference in hardness of the substrates during burnishing, however, the mechanical and electrical runout readings were within the required tolerances.

FIGURE 7 Example of a Burmished Probe Area after Repair (left). The repair region appears dark because of a difference between the base and weld metal; however, the repair met the geometric tolerances, surface finish, and electrical runout (right) required for a probe area.

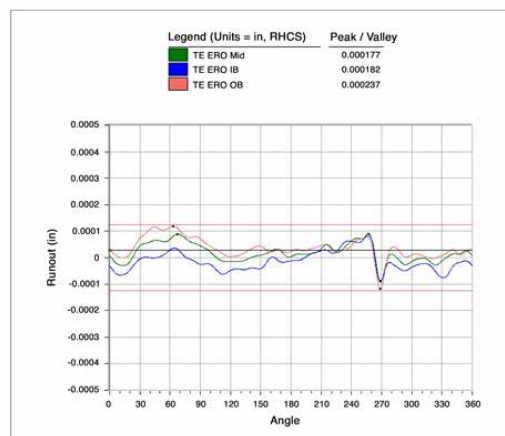
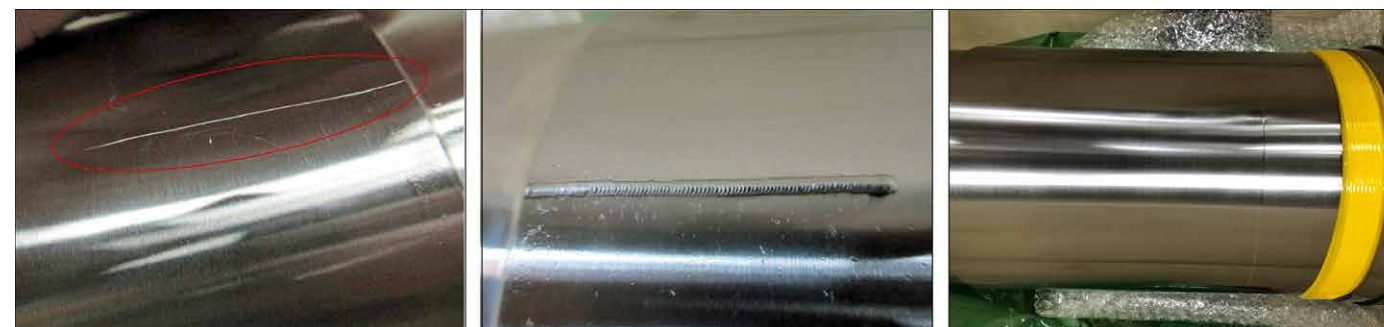
The second shaft was damaged by a box cutter while being unpackaged for assembly, shown in Figure 8. The scratch was approximately 0.003 inches deep and was repaired locally using a single weld bead, which can also be seen in Figure 8. After repair, the shaft was ground back to geometric specifications, inspected, and installed for service.

FIGURE 8 The scratch (circled) in a journal area (left); the same scratch after LBW repair (middle); and the repaired area after final machining (right).

shaft as scrap without a viable repair process. Traditional arc weld was eliminated as an option due to the fact that it would have required welding from the journal area through the coupling end of the shaft. Welding in the coupling area was not feasible in this case due to the strength requirements in that location. Instead, the laser welding process was utilized to perform a localized repair of the scratch, eliminating the need for welding in the coupling area while saving significant processing time. Final grind of the repair area did not require additional stock removal beyond the original drawing tolerance.
