Elliott Repair Capabilities in Asia Pacific

ELLIOTT REPAIR SERVICES

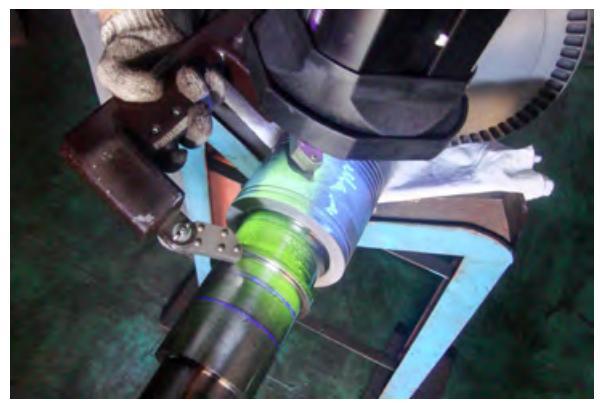
Magnetic particle inspection.

Non-destructive testing is the process of inspecting, testing, or evaluating materials, components, or assemblies for discontinuities or differences in characteristics without destroying the serviceability of the part or system. Elliott's non-destructive testing methods include: dye penetrants, magnetic particle inspection (MPI), ultrasonic inspection (UT), hardness check, and alloy analysis.

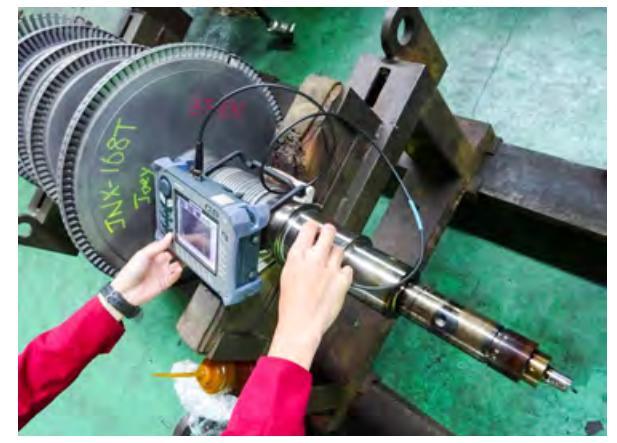
Ultrasonic inspection..

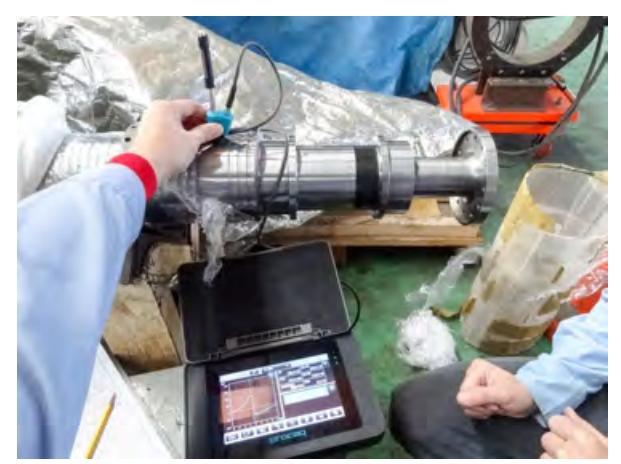
Hardness check.

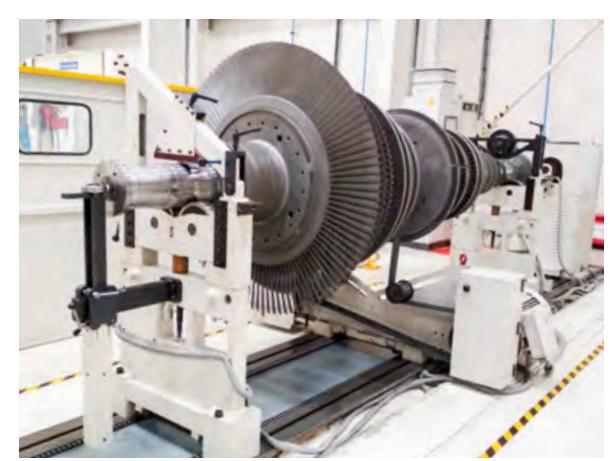
Rotor in balance machine.

When the mass center axis of a rotor is different than its running center axis, the rotor is unbalanced. During operation, centrifugal force causes an unbalanced rotor to vibrate. Vibration causes wear to the bearings, rubbing with stationary parts, and in extreme cases, disintegration of the rotor itself. All repaired or rebladed rotors should be balanced before returning to service. Elliott's dynamic balancing capabilities minimize vibration in any manufacturer's rotor throughout its speed range.

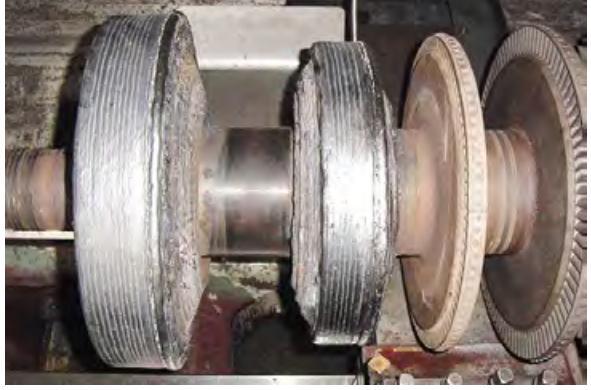
The photos illustrate before and after repairs to an Elliott SBPG-5 turbine rotor.

Disk buildup.

Repairing the disk rather than replacing it offers the dual advantages of lower costs and a shorter lead time. Elliott repaired the disk buildup on two stages, re-bladed and balanced the rotor.

During the disk repair process, we machine away the damaged areas and then weld layer by layer to build them back up to the required thickness and height. After heat treatment to relieve the residual welding-related stress, we machine the welded areas to design dimensions including the grooves and Christmas trees.

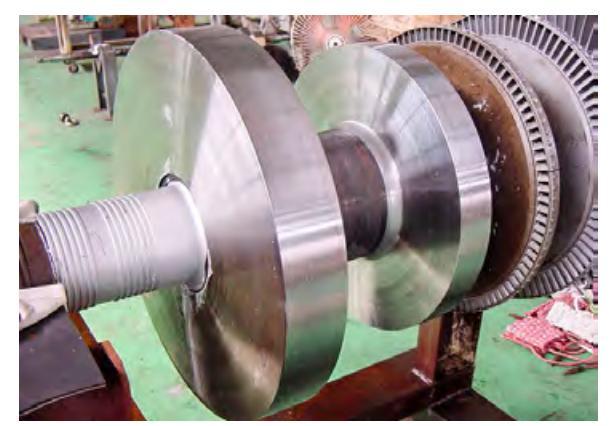
After rough machining.

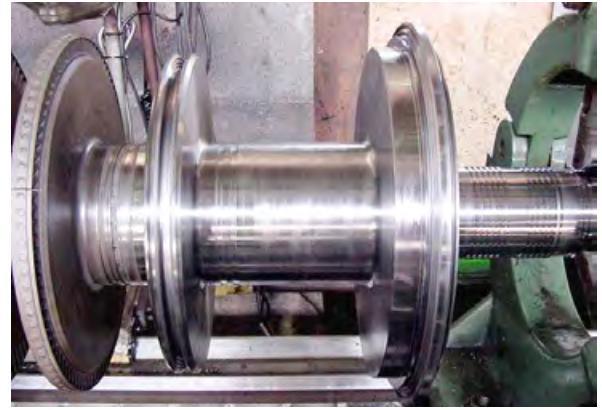
Repaired disk with machined slots.

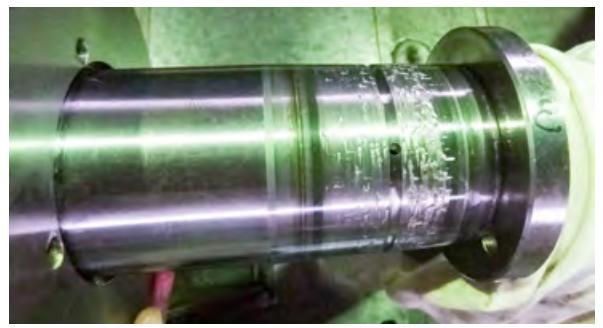
The taper end of a rotor shaft can sustain damage from heavy pitting caused by contaminated oil use during installation, and scratches caused by incorrect installation / removal procedures, or coupling hub slippage because of over-torque. Damage to the journal bearing areas commonly occurs from oil contamination or deprivation, electrostatic discharge, or bearing failure because of high vibration.

The photos illustrate before and after repairs to the taper end of the rotor coupling and the journal bearing areas of the rotor shaft. Using weld repair techniques and PWHT, Elliott repaired the damaged shaft and restored the rotor to its original condition.

Severe hitting marks.

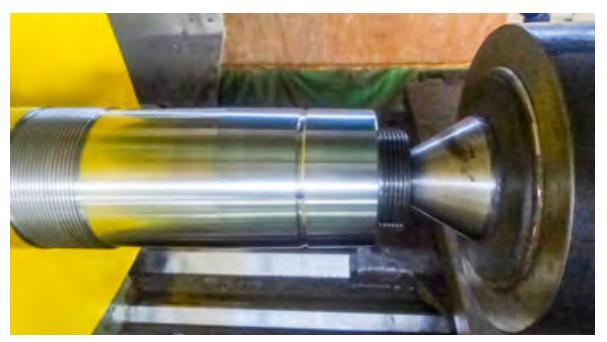
Completed repair.

Depending on the extent of the damage, Elliott can restore a rotor to its original condition within two to four weeks. The repaired weld area has the same properties as the original steel, and does not suffer from issues such as poor bond strength, porosity, or the inappropriate hardness that comes with high-velocity oxygen fuel (HVOF) or other sprayed coating processes. In addition, welding does not have the thickness limitations of HVOF, which is only suitable for a maximum thickness of 0.3 mm.

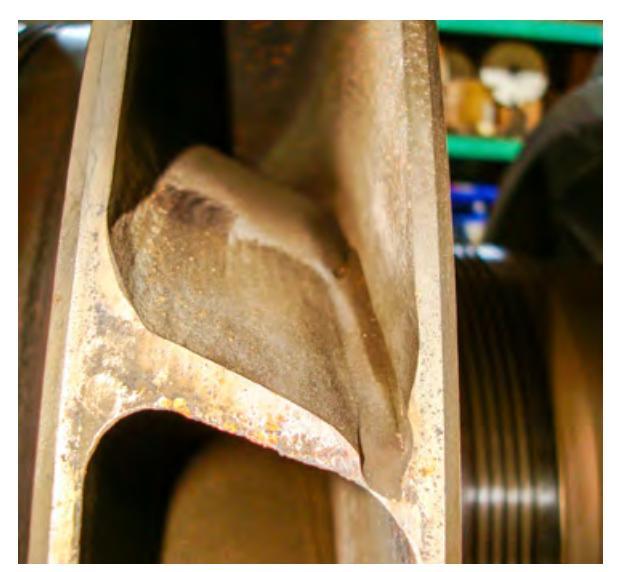
Impellers are subject to erosion caused by condensates in the gas. Scrubbers and separators remove liquids from the gas before it enters the compressor, but liquid carryover always occurs, especially in wet gas compressors. The first-stage impeller is the most likely to suffer erosion damage caused by liquid droplet impact.

Severe erosion.

The photos illustrate before and after repairs to an impeller vane that was severely eroded by condensates.

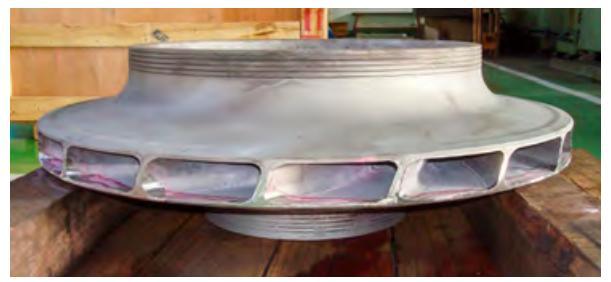
Completed repair.

Welding repair of impeller vanes requires a high level of skill and experience. Usually the impeller vane can be repaired if the discharge measures a minimum of 12.7 mm x 250 mm. To access the damaged area, the impeller must first be disassembled from the rotor. Because of the tight space constraints, the welding must be done manually. Specially designed fixtures prevent heat distortion during welding.

After welding, the impeller must undergo stress relief and spin testing per API 617. Each impeller will be subjected to an overspeed test at not less than 115 percent of maximum continuous speed for a minimum duration of one minute. Impeller dimensions (such as bore, eye seal, and outside diameter) will be measured before and after each overspeed test to make sure that they are within the acceptance criteria before the impeller is reassembled onto the rotor. The rotor is then balanced before being returned to operation. Elliott has successfully repaired eroded vanes measuring 0.5 to 2.0 mm in thickness.

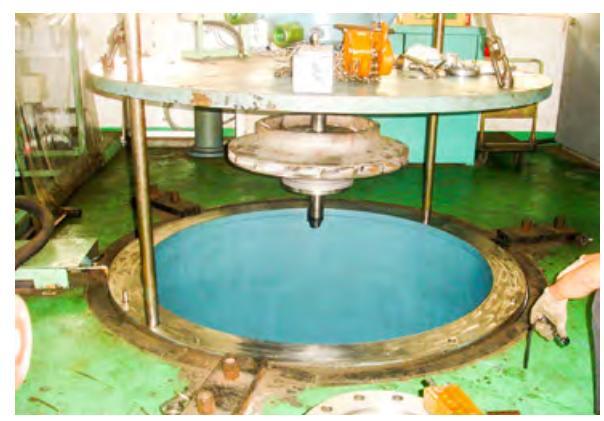
Besides weld repair, a spin test can be used to confirm the integrity of the impeller when there is an increase in the operating speed during a rerate, or to relieve residual stresses when an impeller is impacted by foreign objects.

Spin pit for spin testing.

Spin testing (overspeed testing) is an API requirement for all impellers that have undergone repair. Each impeller must be tested at not less than 115 percent of its maximum continuous speed for a minimum duration of one minute. Impeller dimensions identified by the manufacturer as critical (e.g., bore, eye seal, outside diameter) must be measured both before and after each overspeed test. All measurements and test speeds must be recorded and submitted for the customer's review following the test. Any permanent deformation of the bore or other critical dimensions outside the drawing tolerances is cause for rejection.

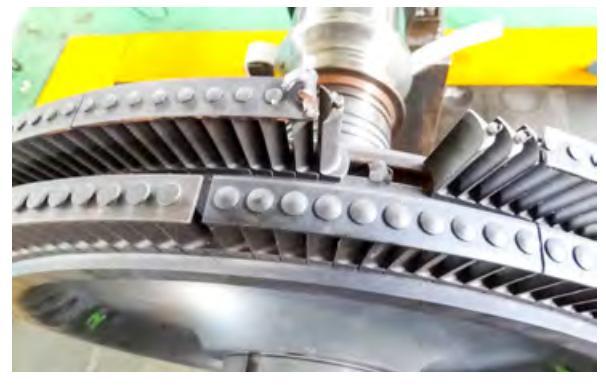
Steam turbine bucket and blade failures are usually related to excessive stress caused by impact, low-cycle or thermal fatigue, or creep; resonance caused by vibration or nozzle passing frequency; or conditions related to the operating environment such as stress corrosion, corrosion fatigue, or erosion.

Broken blades / buckets.

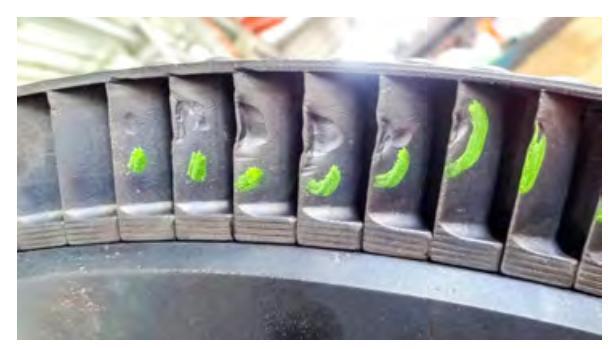
Severe hitting marks.

Elliott chooses a repair strategy based on the extent of the damage. Minor cracks or pitting on the aerodynamic portion of a bucket or blade might be repaired by simple grinding and dressing.

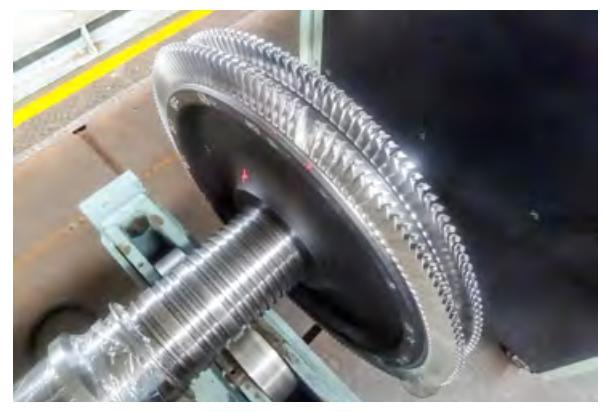
However, major cracks or cracks at the roots require blade replacement. Replacing the blades involves removing the locking mechanism and the blades, followed by installing the new blades and reinstalling the locking mechanism. If the blades have linking and attachment features such as shrouds, lashing wires, or zig-zag pins, they also must be replaced. Once the blades have been replaced, the rotor must be balanced before returning to service. Elliott also offers removal / installation of erosion shields (stellite) for the blades in the last stages.

Reblading with new bucket.

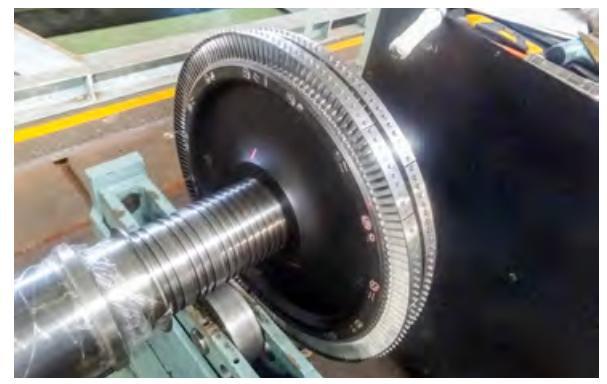
Installing shroud rings.

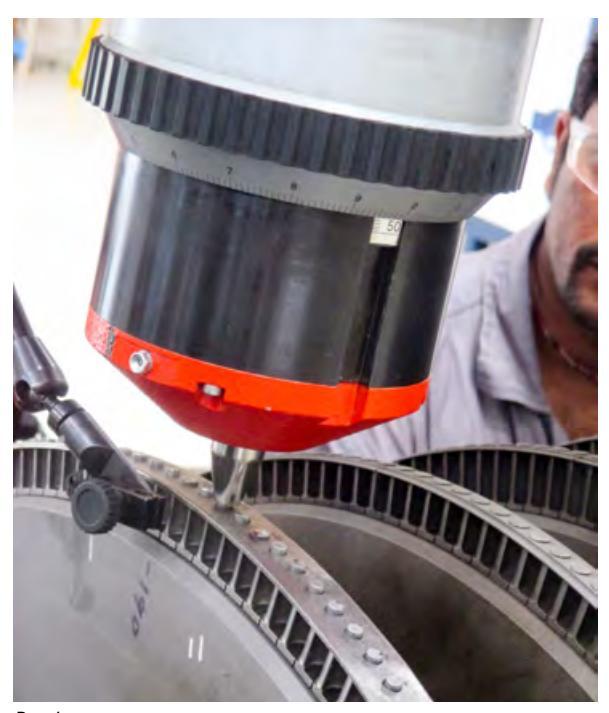
Peening.

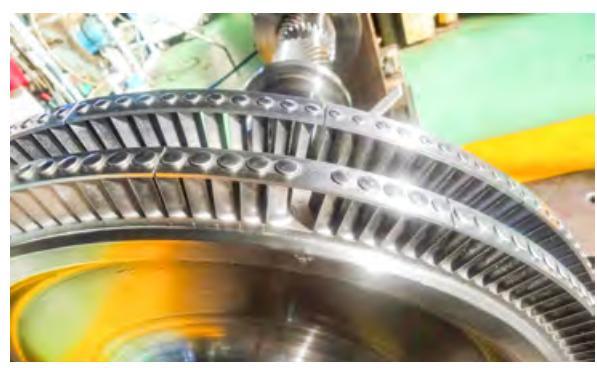
The photos illustrate before and after repairs using different repair strategies.

Completed repair.

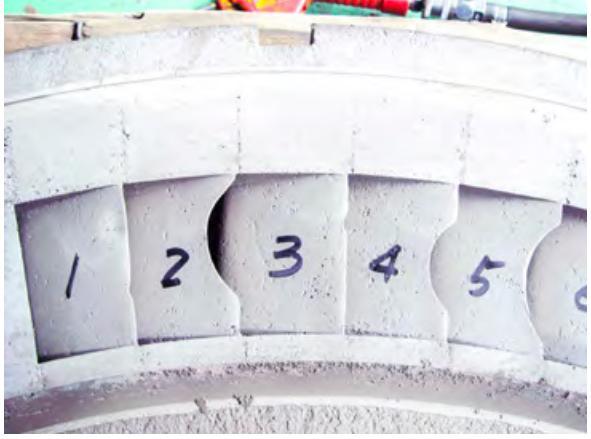
Stator blades are typically damaged due to the impact of ingested foreign objects and/or poor steam quality.

The damaged stator blades shown in the photos cannot be replaced with new ones. Because of the risk of decreased performance efficiency and damage to the rotor if a part breaks off during operation due to propagation of the cracks, the stator blades are repaired for temporary use. The photos illustrate before and after repairs to stator blades as a temporary solution until a new diaphragm can be manufactured and installed.

Damaged stator blade.

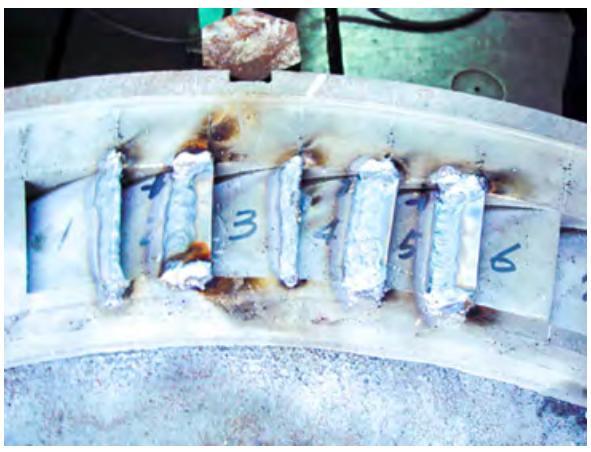
Weld repair.

Lead time for a new diaphragm is six months or more. Restoration of the damaged blades took

three months. Elliott provided a one-year warranty for the repairs that allowed the customer enough time to order a new diaphragm for changeout during the next scheduled overhaul. If the inspection result is acceptable during the next overhaul, the customer can continue to use the repaired diaphragm, or replace it with the new spare diaphragm and keep the repaired one as an emergency spare.

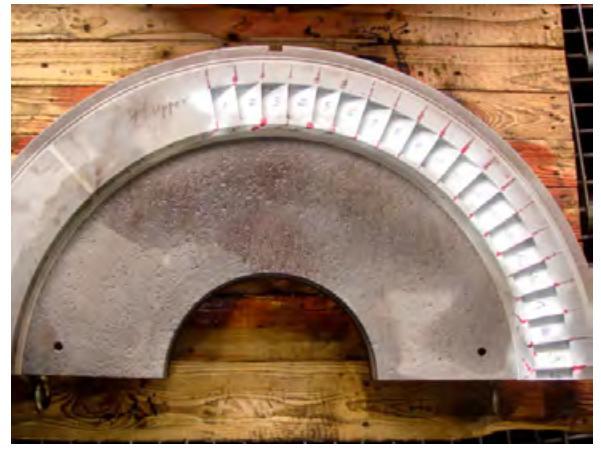
Nondestructive testing after repair.

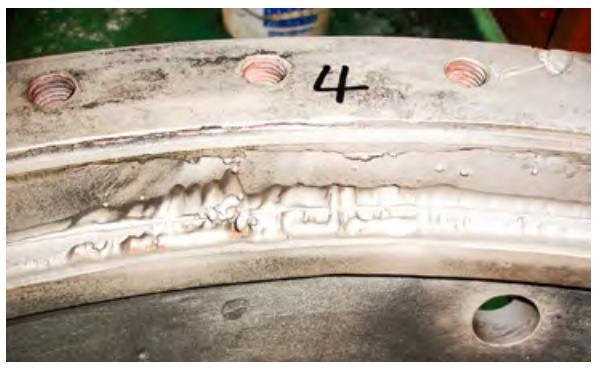
Casing distortion.

Casing distortion is caused by exposure to repeated thermal and / or piping stresses over time. Inner casings distort more easily than outer casings because of their thinner cross-section and higher temperature differentials across the casing walls. Distortion causes interferences, gaps at the horizontal split line, and misalignment of seals. In minor cases, leakage reduces efficiency. In major cases, internal rubbing causes high vibration which may trip the equipment, causing a forced outage. Casing distortion is repaired by welding and machining, followed by PWHT for stress relief. Special fixtures are required.

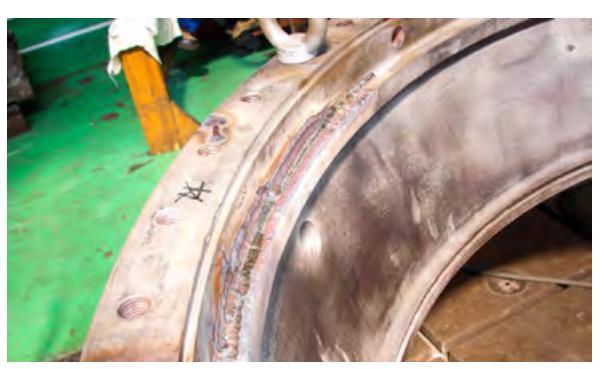
Weld repair.

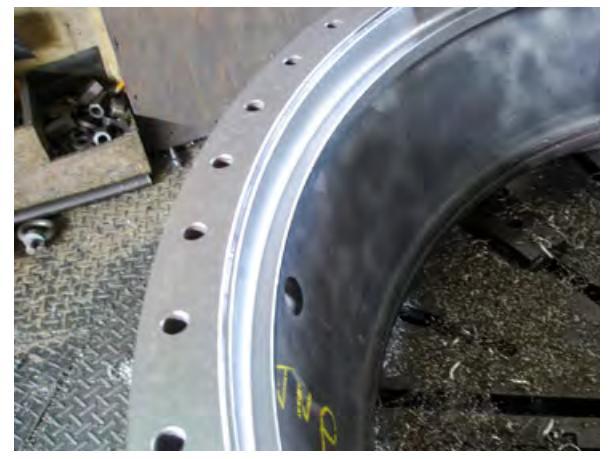
Completed repair.

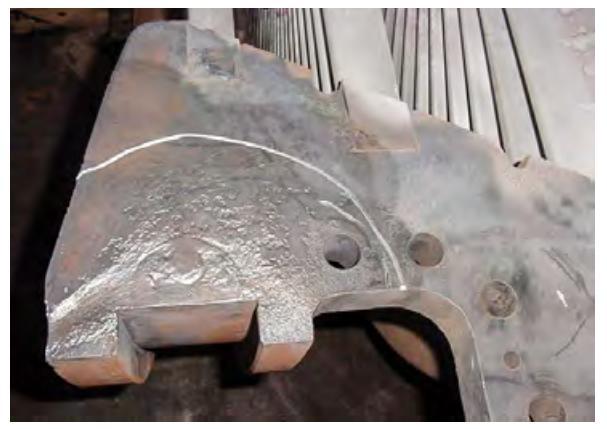
Erosion usually occurs in the low-pressure stages of the turbine where moisture content is high. Moisture can erode the casing, diaphragm, and blades. If there are gaps at the horizontal split line due to casing distortion, the moisture causes further erosion, leading to a larger efficiency drop as the gap increases. Eroded split line areas can be repaired by welding and machining to restore the contact surfaces.

The photos illustrate before and after repairs to a turbine blade carrier that was restored by welding buildup.

Worn blade carrier.

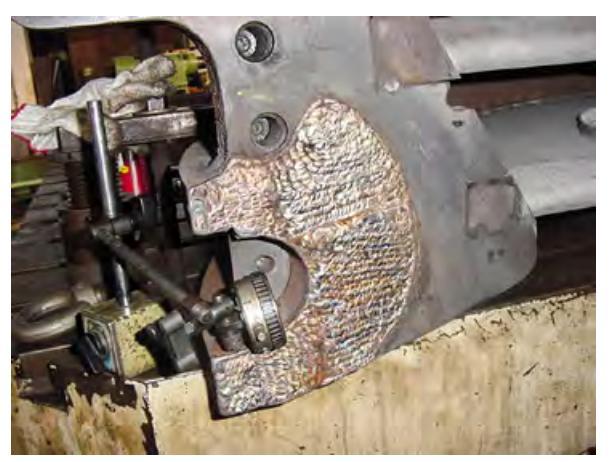
Weld repair.

Elliott identified the base material, selected a suitable filler, and welded the eroded area, followed by PWHT for stress relief. Polishing the split line surface provided good contact between the top and bottom surfaces. After repair, the surface flatness must be within 0.03 mm when the repair area is smaller than 200 mm2 (or smaller than 30 percent of the total split line surface). Typical repair time is 7 to10 days for such damage.

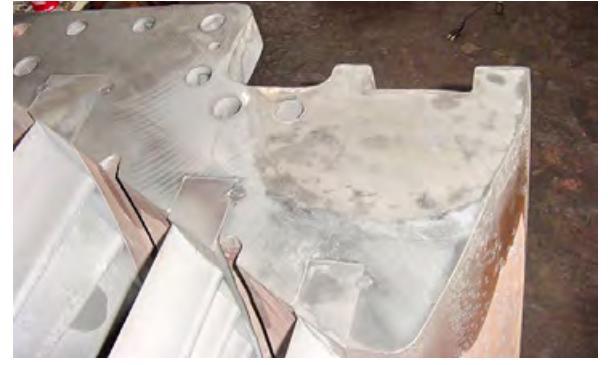
Completed repair.

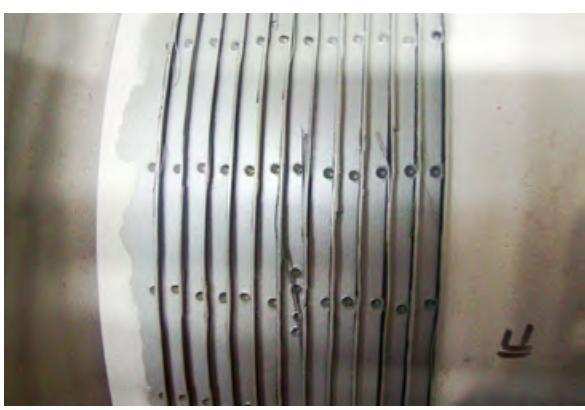
Seal fins minimize steam turbine leakage loss. Rubs suffered during rotor excursions can damage seal fins, resulting in larger clearances and higher leakage, and reduced turbine efficiency and performance. Damaged seal fins must be replaced.

The photos illustrate damaged seal fins and a new seal fin replacement by Elliott.

Damaged seal fins.

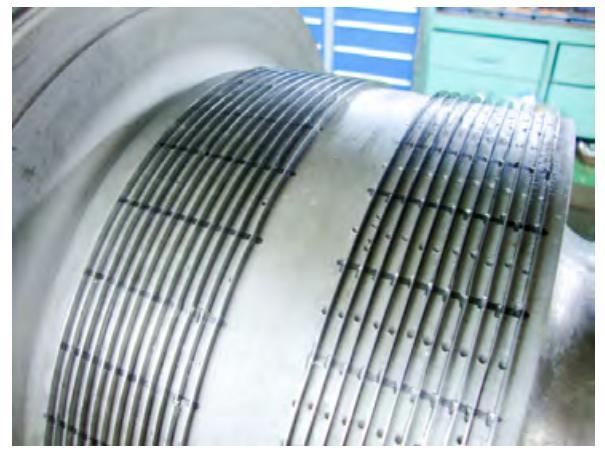
New sealing strip.

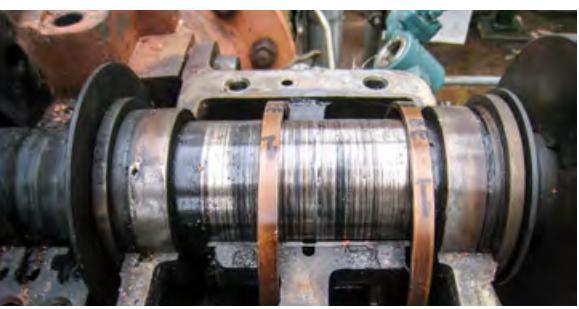
Single-stage steam turbines are commonly used to drive lube oil pumps, condensate pumps, generators, and process pumps. In these types of applications, wet steam often causes erosion and corrosion to the shaft packing area, and wiped bearings caused by lube oil issues can damage the shaft journal bearing area. When the shaft is damaged, Elliott recommends shaft replacement rather than replating it for higher reliability without the risk of delamination due to poor bond strength.

The photos illustrate typical shaft damage, removal, and replacement.

Damaged journal bearing area.

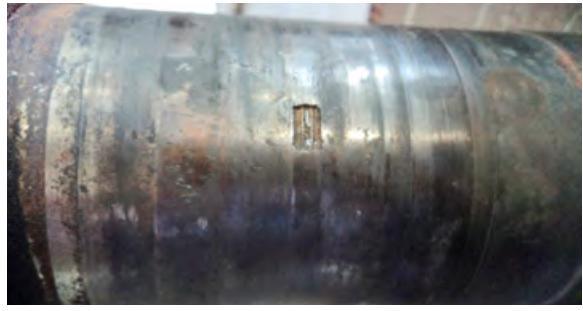
Damaged packing area.

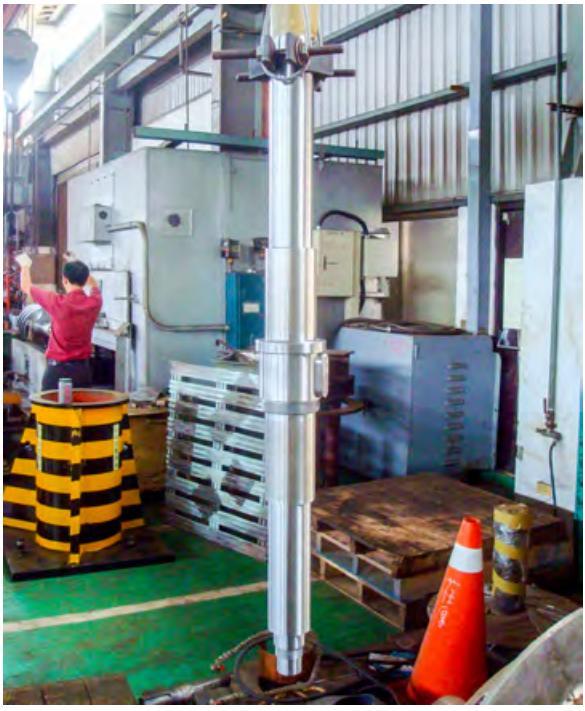
New rotor shaft.

Elliott can complete shaft replacement within a week, subject to parts availability. The rotor is then balanced before resuming operation.

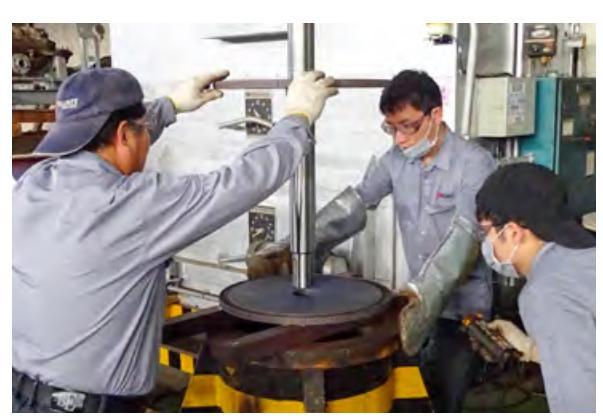
New shaft installation.

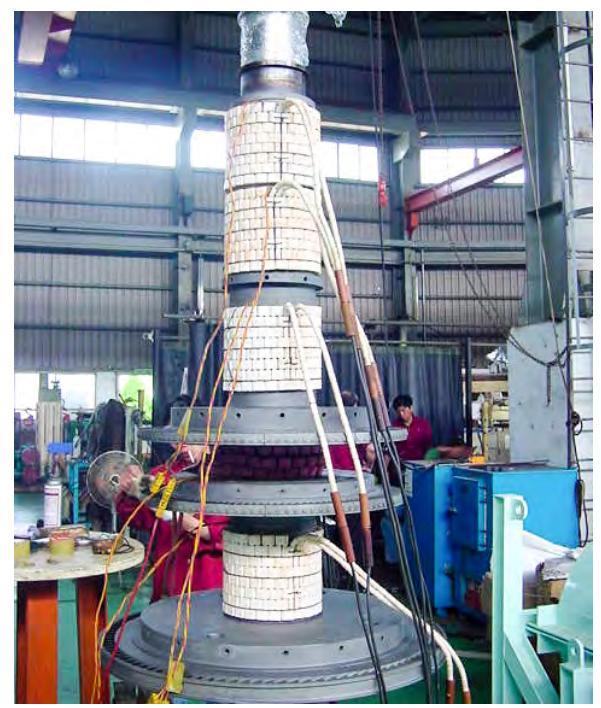
Stress relief is achieved through heat treatment and is required after welding. This kind of PWHT typically takes two days. Besides PWHT, heat treatment also can be used to straighten a bent rotor. Depending on the extent of the bend, rotor straightening takes 5 to 10 days.

Shaft undergoing stress relief for straightening.

When wet steam contacts a hot turbine rotor, it causes partial quenching and bending of the rotor. This usually happens when sealing steam is switched to an external supply during the shutdown process, and condensates are accidentally introduced into the hot rotor at the packing area. The rotor straightening process involves hanging the rotor vertically and applying heat using a programmable heater controller that records heat history. Using this method, Elliott has successfully straightened a rotor with 0.2-mm runout.

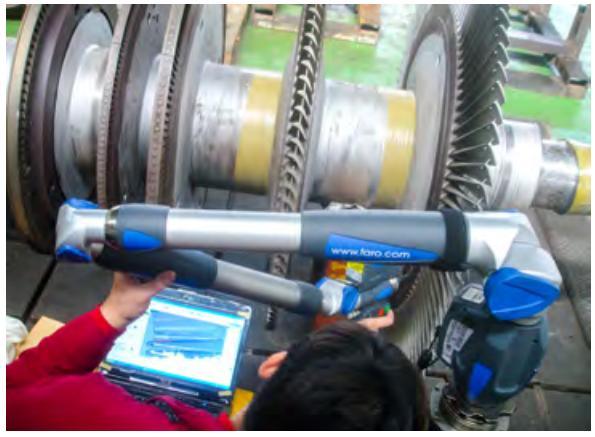
During service outages, Elliott uses CMM tools to record the geometry of internal components, and a PMI gun to conduct a material analysis.

Scanning.

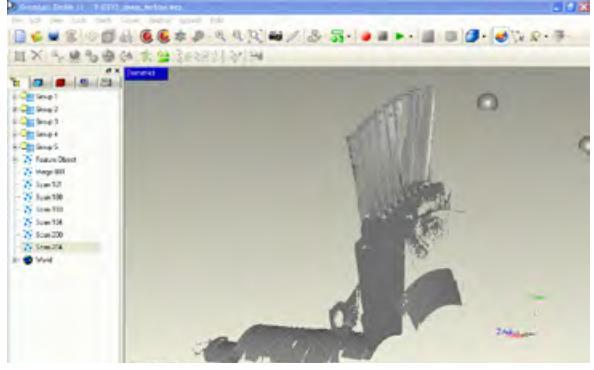
Modeling.

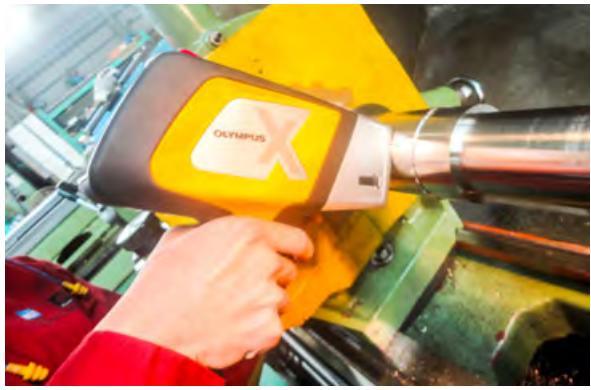
Material analysis.

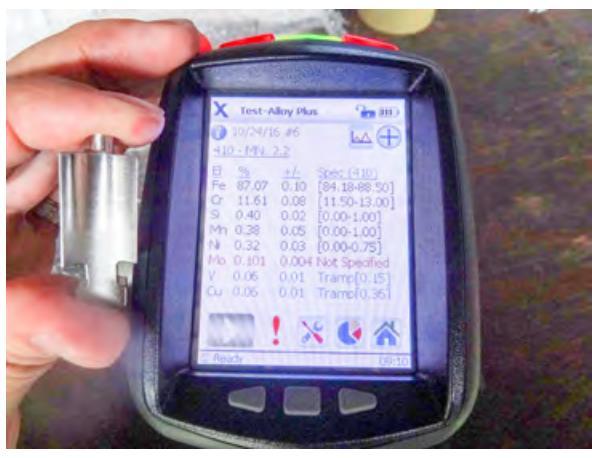
Material identification.
